R.H. Kaye, R. Jones and P. Hayes

# Orion P3C Horizontal Stabiliser Strain Survey and Corrosion Repair Development

DSTO-TR-0196

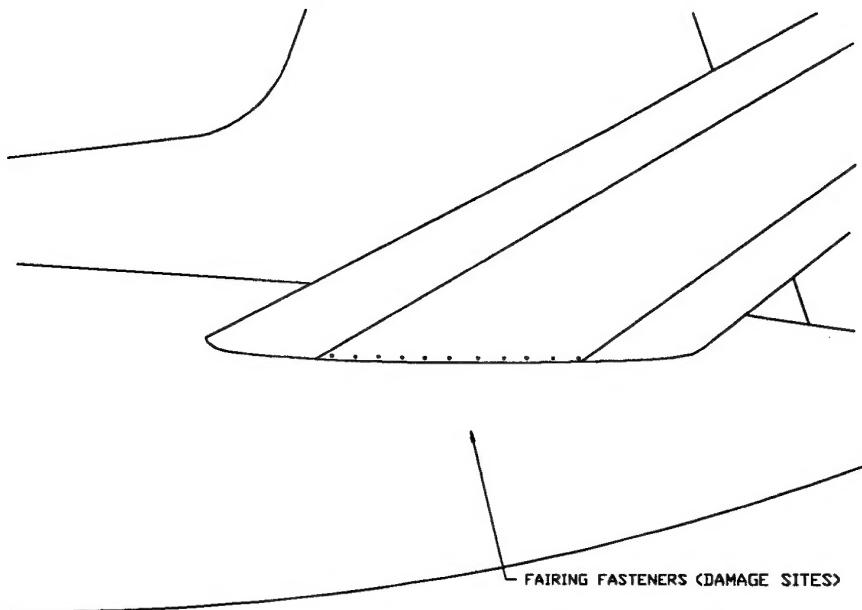
*Figure 1: Corrosion Damage Locations*

In recent years P3 - Orion aircraft in service with the Royal Australian Air Force have experienced corrosion damage to skin panels at the root of the horizontal stabiliser. The lower root fairing attachment fastener holes are common corrosion sites, see Figure 1. The standard repair for this damage involves a series of mechanically fastened doublers and requires numerous additional fastener holes to be drilled through the skin panels [1]. The latter part of this report details an alternative repair which uses a bonded doubler and therefore requires minimal use of additional mechanical fasteners. This repair would do less irreversible damage to the structure and is expected to have a longer fatigue life due to the reduction of fastener hole stress concentrations.

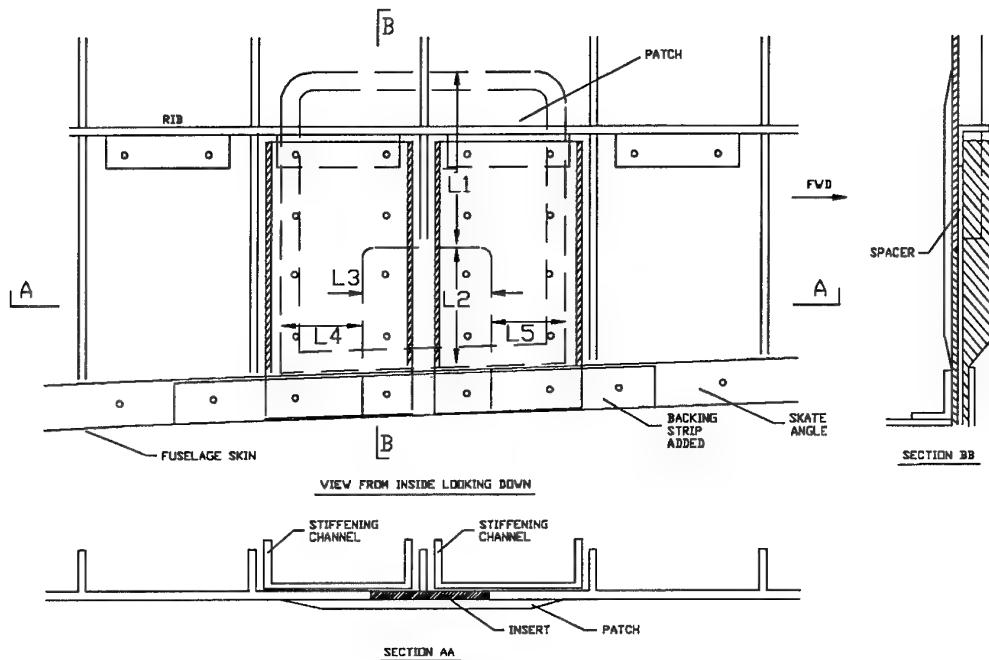
Figure 5: Proposed Bonded Repair

The damage sites are typically centred within 45 mm from the edge of the skate angle at the fuselage skin connection. There is not sufficient overlap distance inboard of the damage to transfer the load from a normal bonded doubler back into the skin. This repair option, from [11], is based on the removal of a rectangular section containing the corrosion damage and is shown below in Figure 5. This rectangle extends underneath the skate angle to the end of the skin panel. The removed skin is replaced and stiffened against buckling and bending with a length of channel section and spacer on the inside. A bonded doubler of the same material is applied to the outside to transfer the load from the outboard skin to the insert. The insert picks up the fasteners in the skate angle in the same way as the original material but with a reinforcing strap underneath which picks up two extra fasteners. This repair has the advantage that it can cope with full thickness damage, up to and underneath the skate angle.

The results of the analysis show that the design is feasible. A repair which incorporates the characteristics detailed and calculated in this analysis can be expected to be a satisfactory, airworthy repair. The analysis shown here cannot however be considered to be a complete repair design package. A repair analysis which applies these same checks to the individual repair case being examined must be produced and checked. This would then form a key element of the complete repair design package. Other essential elements of the repair package would include details of the surface preparation and repair application procedures to be used. The details provided in [13] are an invaluable aid in specifying these items.

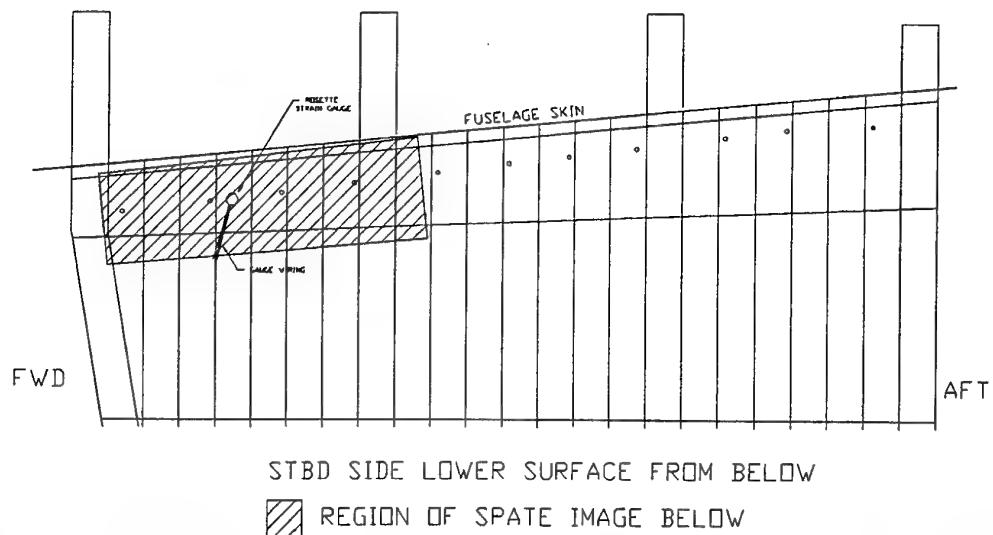
Figure 6: SPATE Region 1

Despite the low signal levels, the SPATE results clearly show the load transfer from the skin planks to the continuous members. The plotted quantity is proportional to the bulk stress (sum of the principal stresses). The peak stresses are concentrated in small regions near the inboard corners of each plank as expected. Away from the spars at the root the stresses in the skin are very low except in the forward plank which has more restraint along its inboard edge. The load transfer region (transfer between the skin planks and the spar caps) is shown to be confined to the inboard 100mm of stabiliser.

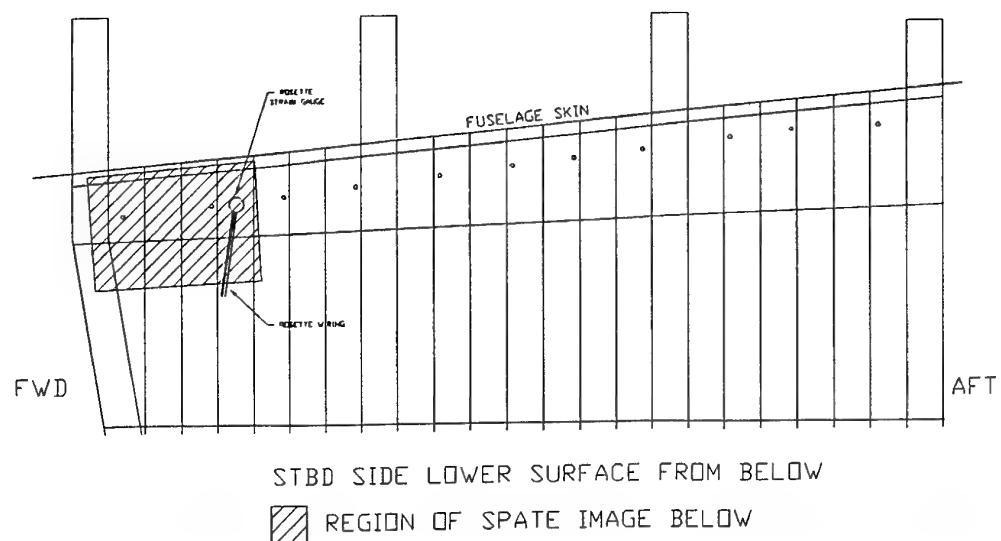
Figure 9: SPATE Region 4

It is interesting to note that, in Figure 9, the full depth internal rib frame can be seen as a region of lower signal. Close examination of the figures also reveals that the fasteners coupling the skin to the trailing edge spar can be seen as regions also with low infra-red signatures. The stress pattern at an open fastener hole in the stabiliser skin is shown in Figure 13. Here the orientation of the stress pattern around the hole reveals the direction of the principle stresses in the region.

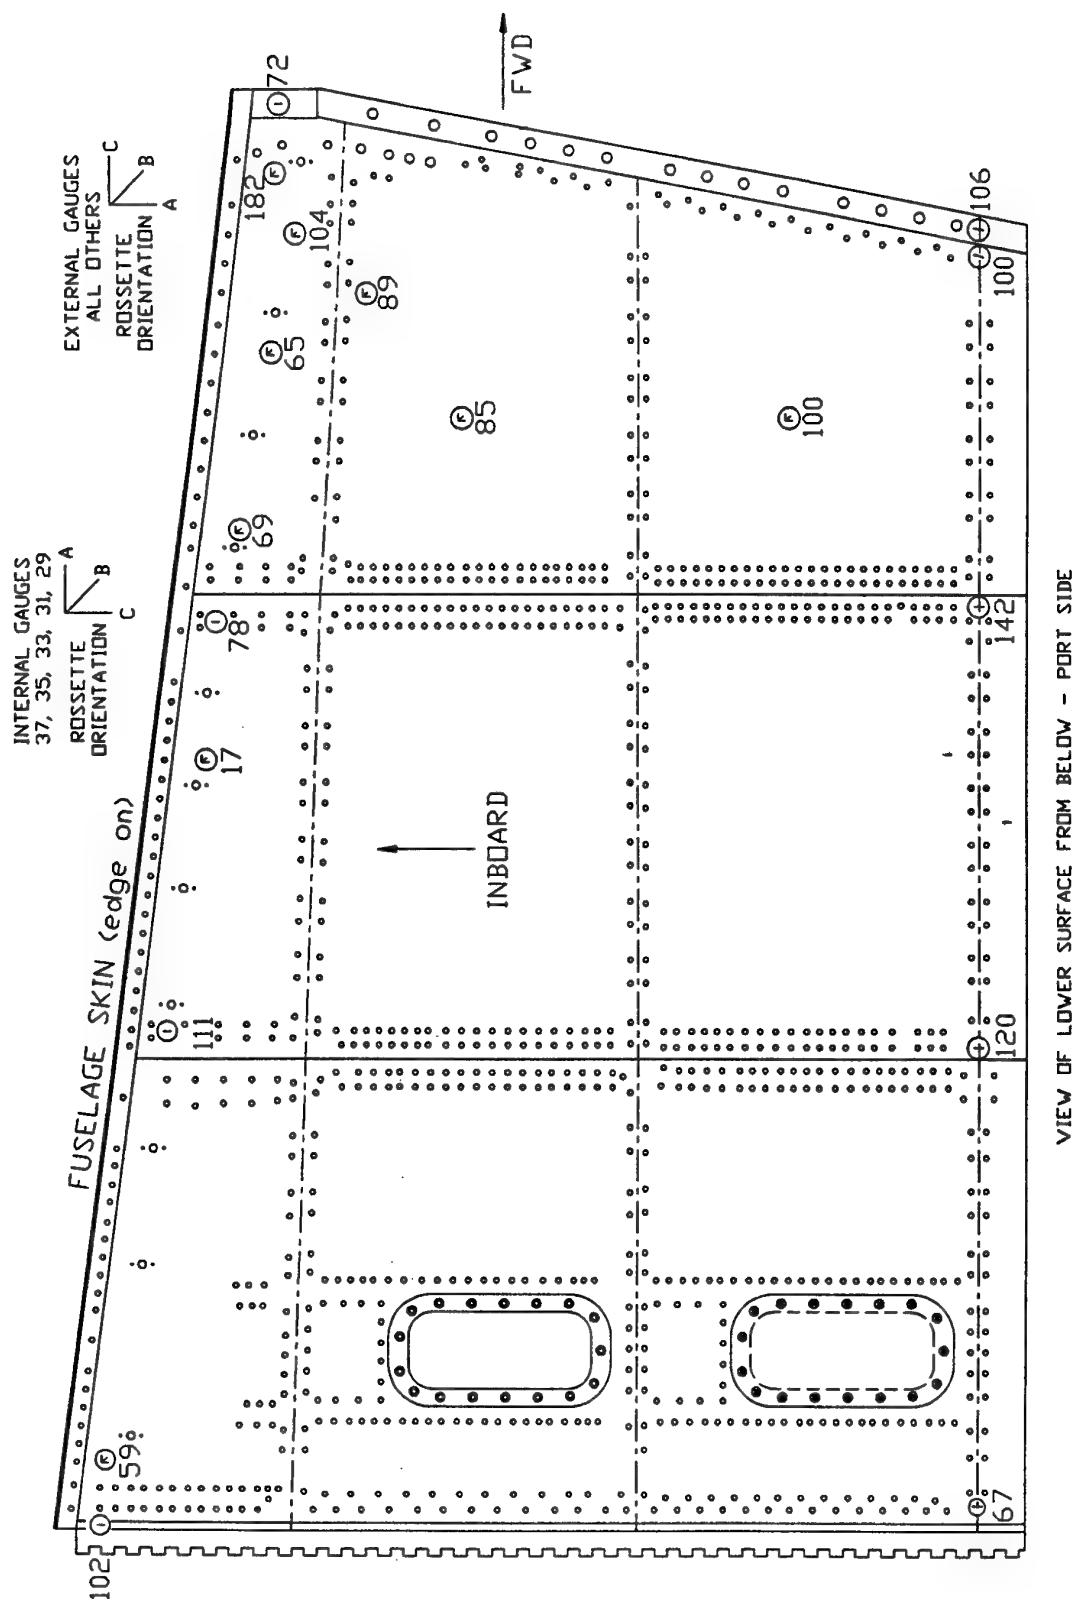
Figure 18: Spanwise Stresses (Compressive) at 60% of Limit Load in MPa

These stresses (shown at their locations in Figure 18) are the primary bending stresses brought about by the skin planks and spar caps acting as flanges of a box beam separated by the spar webs and rib frames. As they are measured on the lower surface with the bending being in a downwards direction all spanwise stresses are compressive.

Variations in the spar stresses are brought about by their proximity to the loading line and differences in section areas. Values are all low enough to suggest that the stabiliser root would easily survive ultimate design load.

High skin stresses in the forward corner of the forward plank (also revealed in the SPATE plots) suggest that the skin provides the stiffer path into the fuselage carry-through structure than the forward spar cap. The skin has about double the spanwise strain of the spar cap. The values suggest that yielding would only occur above design limit load. In that case, some of the load would be shed into the forward spar cap.

The value of 65 MPa in the middle of the forward plank and the value of only 17 MPa near the middle of the centre plank is a good guide to the differences in spanwise edge restraint which were also observed in the thermo-elastic images.

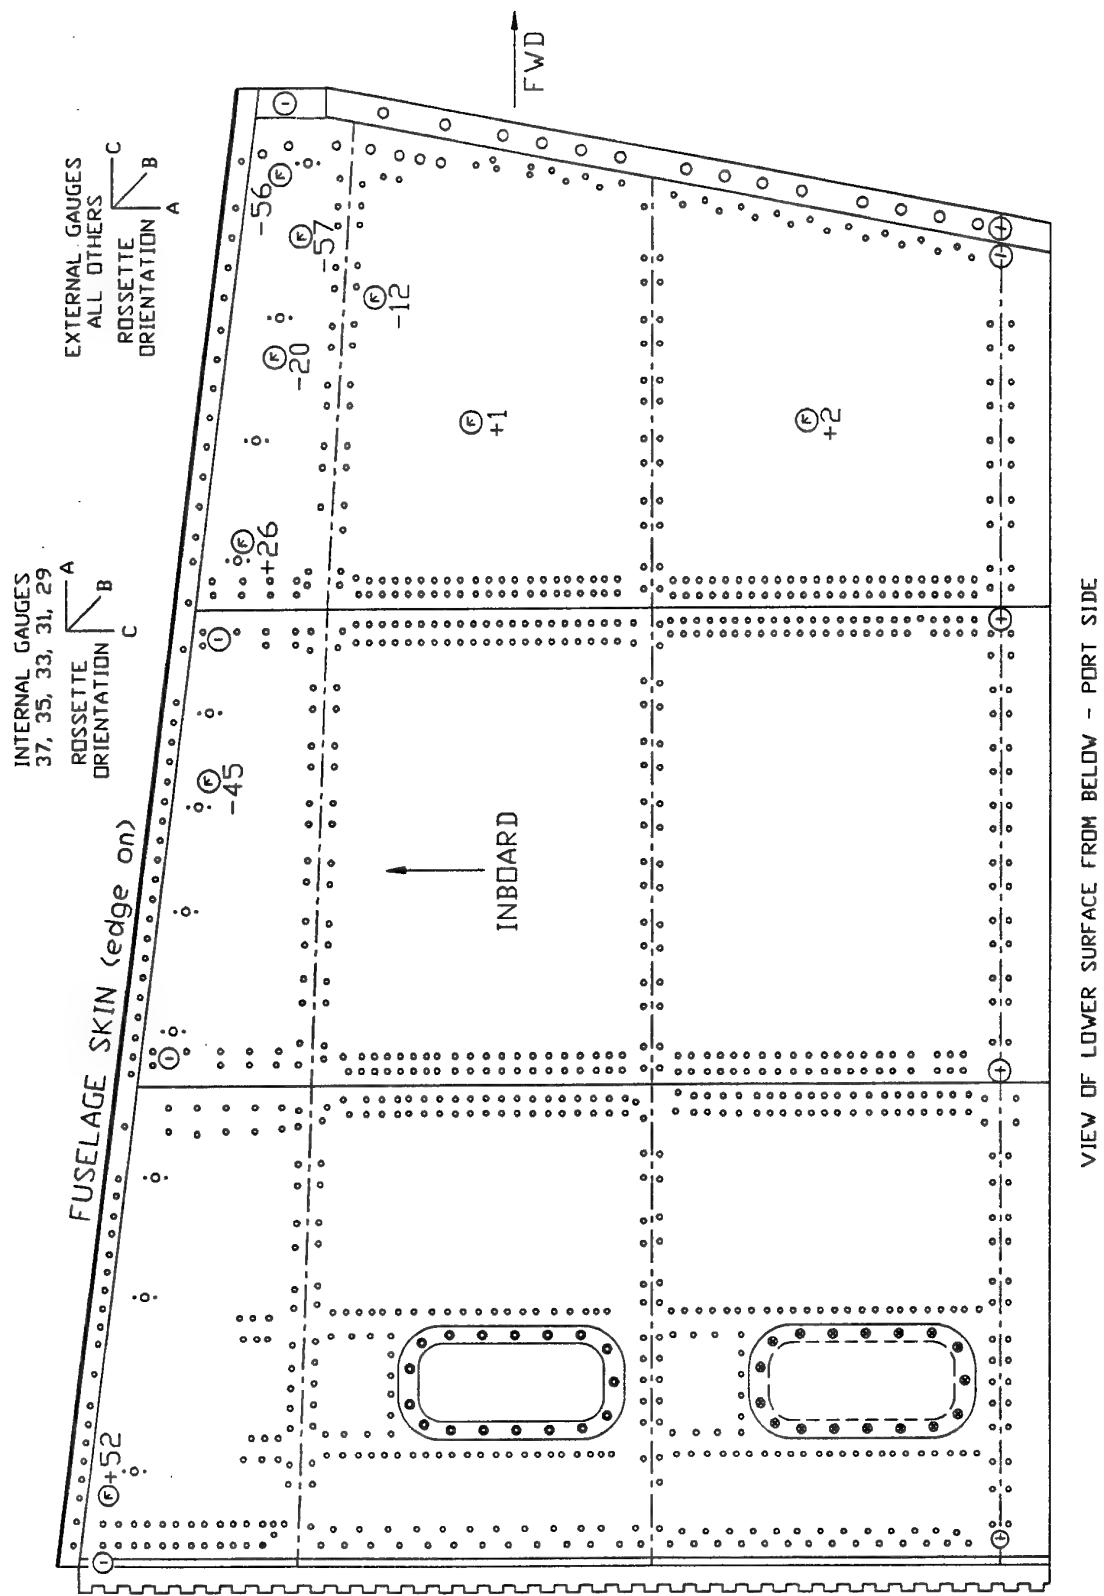
Figure 19: Shear Stresses at 60% of Limit Load in MPa

The sign and magnitude of the shear stress values (Figure 19) show the effect of the load transfer into the spar caps. The change in sign from one side of the spar caps to the other is strong evidence of this load transfer. Away from the root region the very low values show that stabiliser torsion has a minimal effect on skin shear stress. A separate strain survey was performed using a 25% spar line for loading instead of a 33% spar line. The net change in shear stress was quite uniform across all the gauges and for the outboard gauges, only about +6 MPa (Table 3).

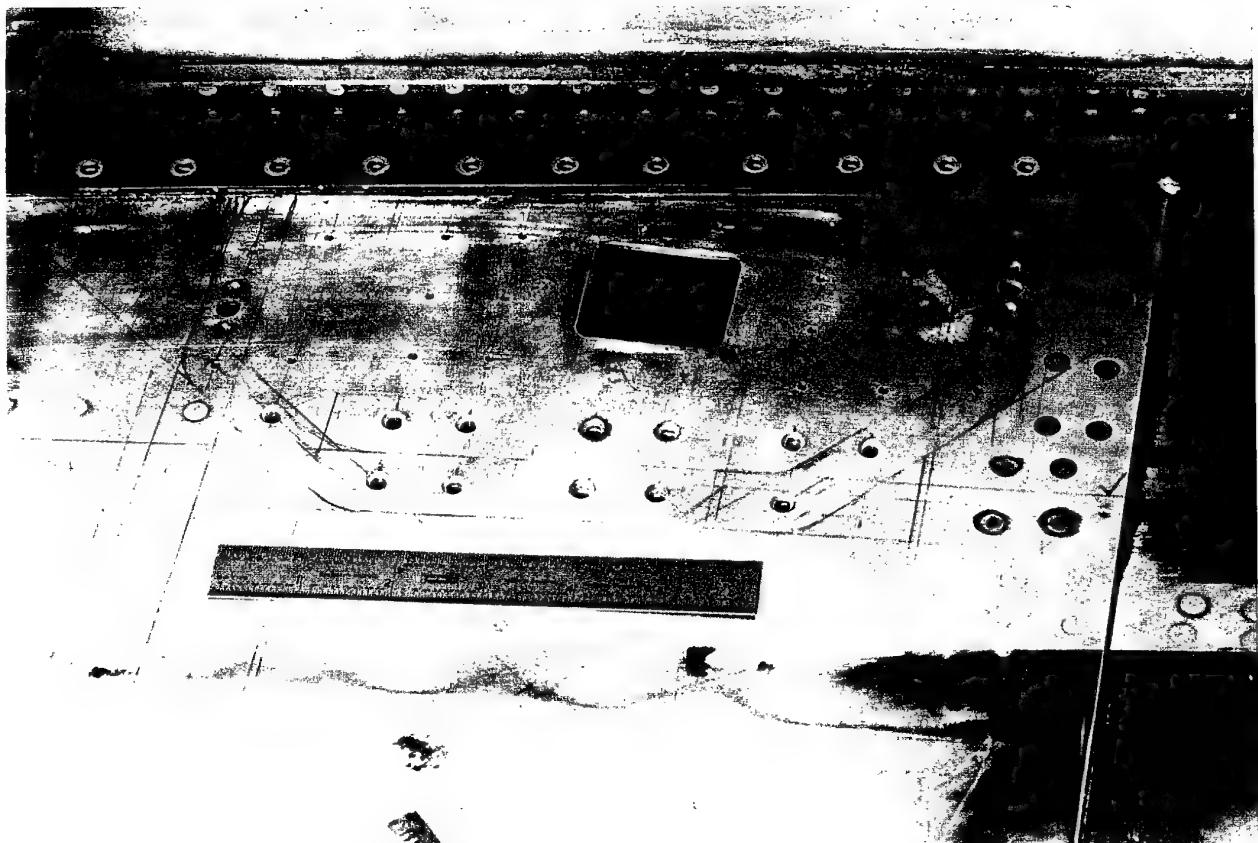
*Figure 20: Standard Repair at Preliminary Stage*

Bonded doubler skin repairs have been extensively investigated in [2,3,4,5,6]. In this case, the damage sites are close to the connection with the fuselage skin and the normal overlap distances are not available. A more novel repair design using a skin panel cut-out and bonded doubler has been proposed [11] and is described in section 4. The standard repair and the bonded repair were installed on opposite sides of the test article and thermo-elastic data from the surrounds of the repair has been collected.

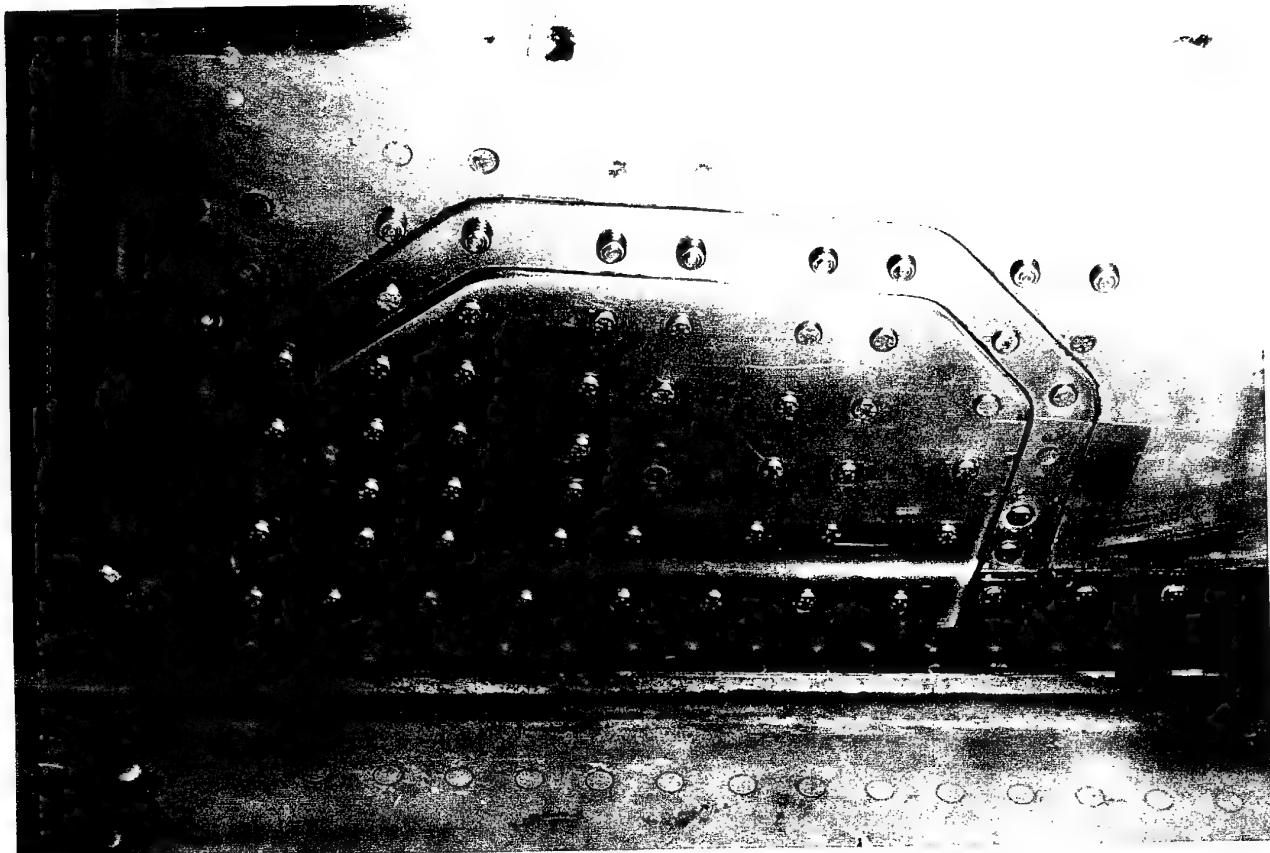
*Figure 21: Standard Repair on Completion*
